**THE STREAMBANK EROSION CONTROL
EVALUATION AND DEMONSTRATION ACT OF 1974
SECTION 32, PUBLIC LAW 93-251**

Appendix E - Missouri River Demonstration Projects

Volume 2 of 2

4. TITLE (and Subtitle) LITERATURE SURVEY AND PRELIMINARY EVALUATION OF STREAMBANK PROTECTION METHODS		5. TYPE OF REPORT & PERIOD COVERED Final report
		6. PERFORMING ORG. REPORT NUMBER

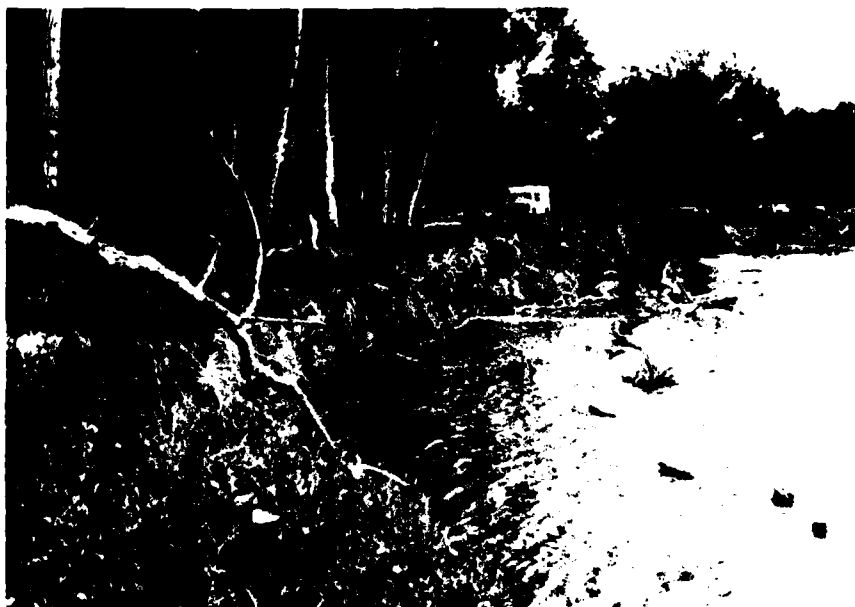
**PHOTO 18. REINFORCED REVETMENT 796.45* APPROXIMATELY ONE YEAR AFTER
COMPLETION. THIS PHOTO, LOOKING U/S, PROVIDES A VISUAL COMPARISON OF
THE ORIGINAL SEVERELY ERODING UNPROTECTED BANK CONDITION AND ITS
PRESENTLY STABILIZED CONDITION
(Photo Taken 5 October 1979)**

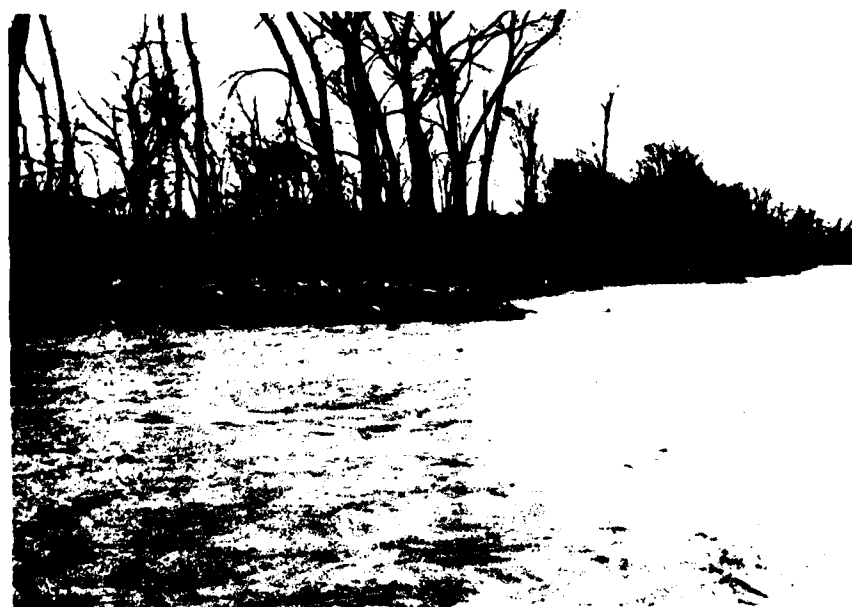
PHOTO 25. COMPLETED HARDPOINT 796.6*
(Photo Taken 13 April 1979)

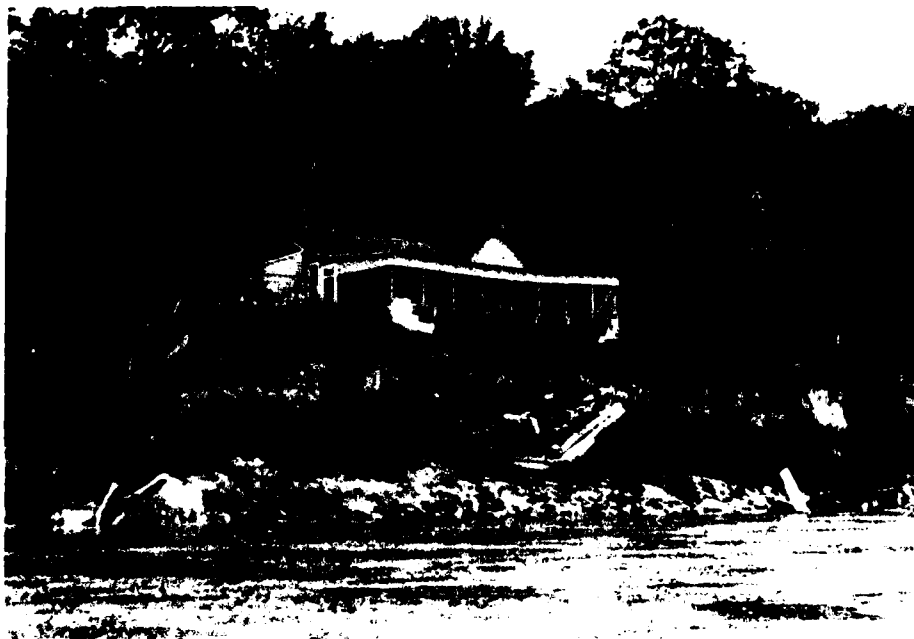
PHOTO 33. TYPICAL SEVERE EROSION CONDITIONS AT RIVER MILE 783.2*
 (Photo Taken 12 April 1977)

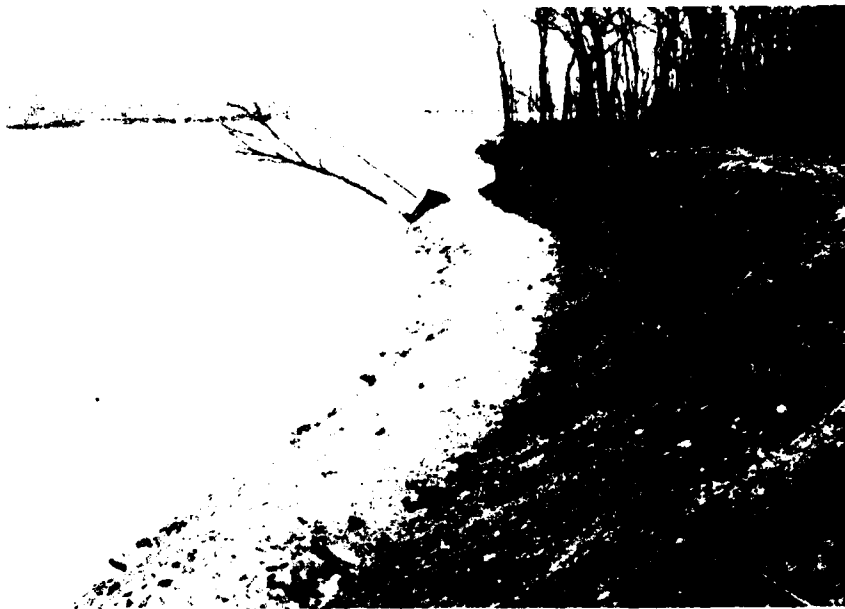
PHOTO 34. SEVERE BANKLINE EROSION CONDITIONS AT RIVER MILE 786.2*
 (Photo Taken 5 October 1979)

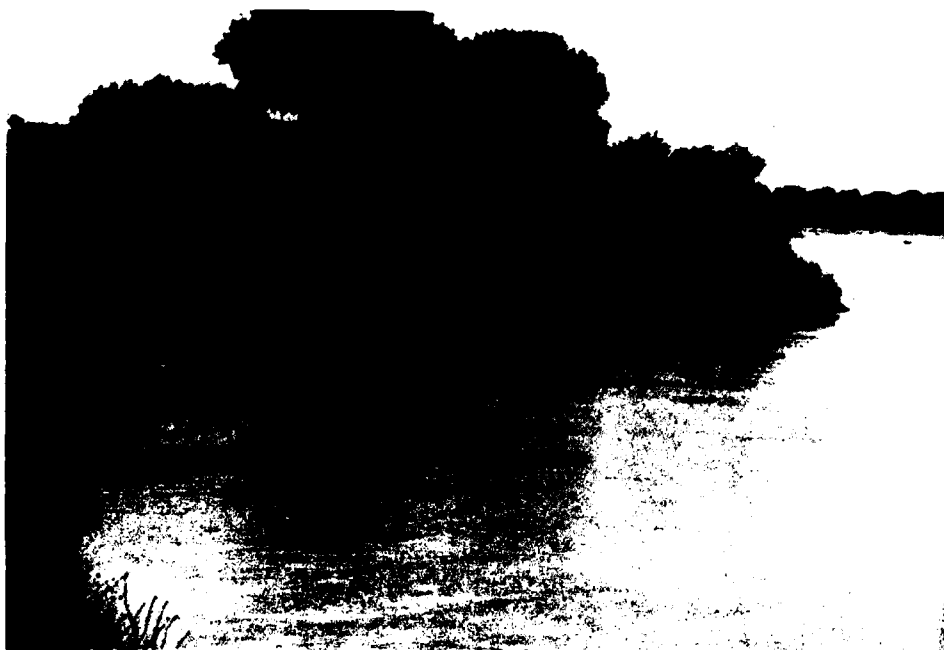
**PHOTO 59. WINDROW REVETMENT 771.9* IN ITS STABLE CONDITION, 2 YEARS
AND 4 MONTHS AFTER COMPLETION. THE STRUCTURE WAS VERY
EFFECTIVE IN ESTABLISHING NATURAL VEGETATION GROWTH
(Photo Taken 13 September 1979)**

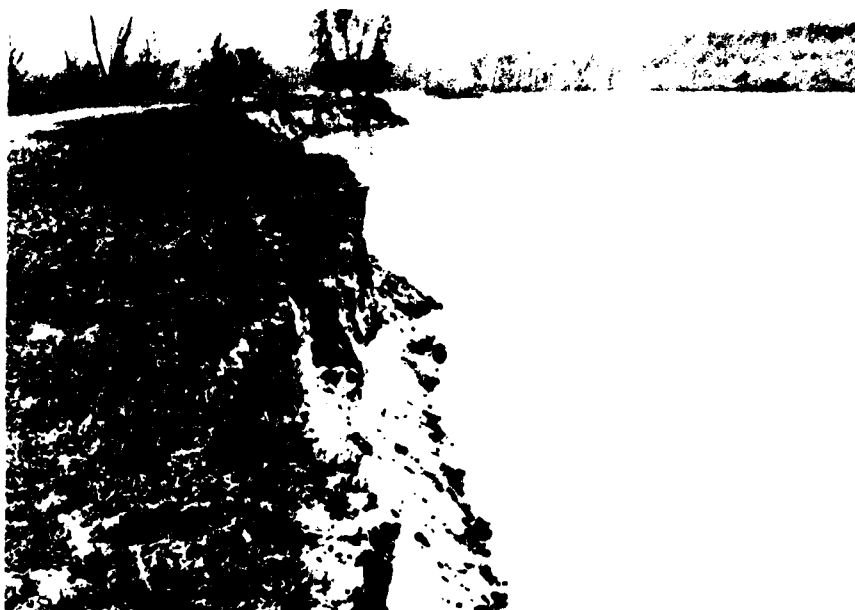
**PHOTO 80. COMPOSITE REVETMENT 754.05* SHOWS CONSIDERABLE DAMAGE TO THE UPPER BANK CELLULAR CONCRETE BLOCK PROTECTION CAUSED BY NATURAL RUNOFF, WAVE WASH, AND LEACHING
(Photo Taken 5 September 1980)**
